Manhole Inspection Summary

Manhole # S07MM1008MH

Record Plat: **07MM1** Node: **008** Status: **Found**

Location Address: **ALLEY OFF OF 5103 LITCHFIELD AVE** Cross Street: **ALLEY-BELVEDERE-SPAULDING**

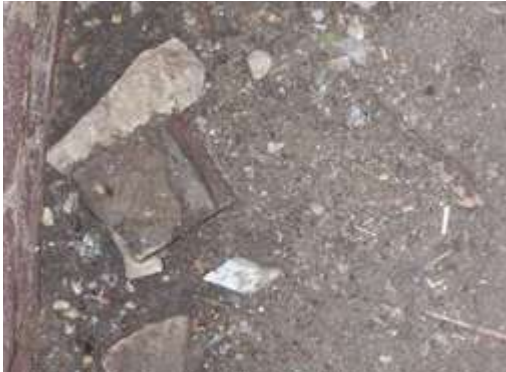
Defect 1

DEBRIS ON BENCH

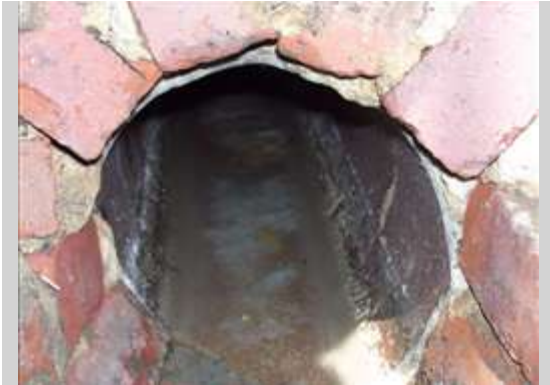
12 O'Clock Outflow

8 in. Circular Gravity Sewer
Pipe Out @ 12 O'Clock

Pipe Height: (in.) Direct
Pipe Material: **Clay** ☐ Pipe Lined
Invert Depth: **3.25** (ft.) Flow Characteristics: **Slow**
Deposits: ☒ None ☐ Mud ☐ Sludge ☐ Debris ☐ Grease
Silt Depth: (in.) Deposits Extent:
Infiltration: **None** Pipe Seal Cond: **Sound**

Drop: **None**

Connects To: **Manhole**

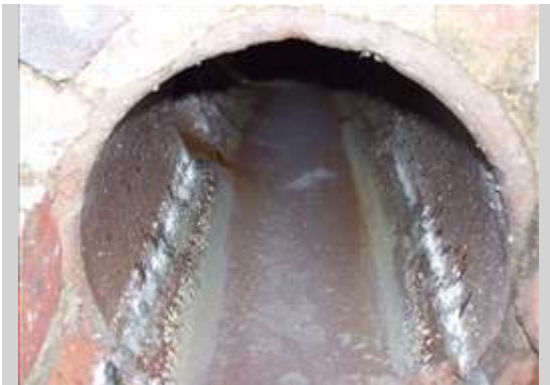
6 O'Clock Inflow

8 in. Circular Gravity Sewer
Pipe In @ 6 O'Clock

Pipe Height: (in.) Direct
Pipe Material: **Clay** ☐ Pipe Lined
Invert Depth: **3.23** (ft.) Flow Characteristics: **Slow**
Deposits: ☒ None ☐ Mud ☐ Sludge ☐ Debris ☐ Grease
Silt Depth: (in.) Deposits Extent:
Infiltration: **None** Pipe Seal Cond: **Sound**

Drop: **None**

Connects To: **Stub connection / abandoned**

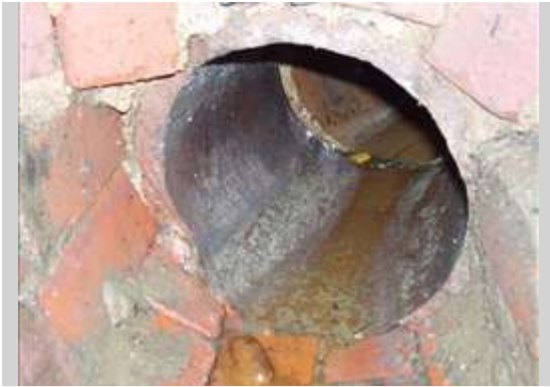
7 O'Clock Inflow

8 in. Circular Gravity Sewer
Pipe In @ 7 O'Clock

Pipe Material: **Clay** ☐ Pipe Lined

Invert Depth: **3.22** (ft.) Flow Characteristics: **Slow**

Deposits: ☒ None ☐ Mud ☐ Sludge ☐ Debris ☐ Grease

Infiltration: **None** Pipe Seal Cond: **Sound**

Drop: **None**

Connects To: **Manhole**
